**NO FURTHER ACTION UNDER
COMPREHENSIVE ENVIRONMENTAL
RESPONSE, COMPENSATION,
AND LIABILITY ACT
STUDY AREA P19
CLEARING, TRACKED ROAD**

**U.S. ARMY ENVIRONMENTAL CENTER
ABERDEEN PROVING GROUND, MARYLAND**

APRIL 1995

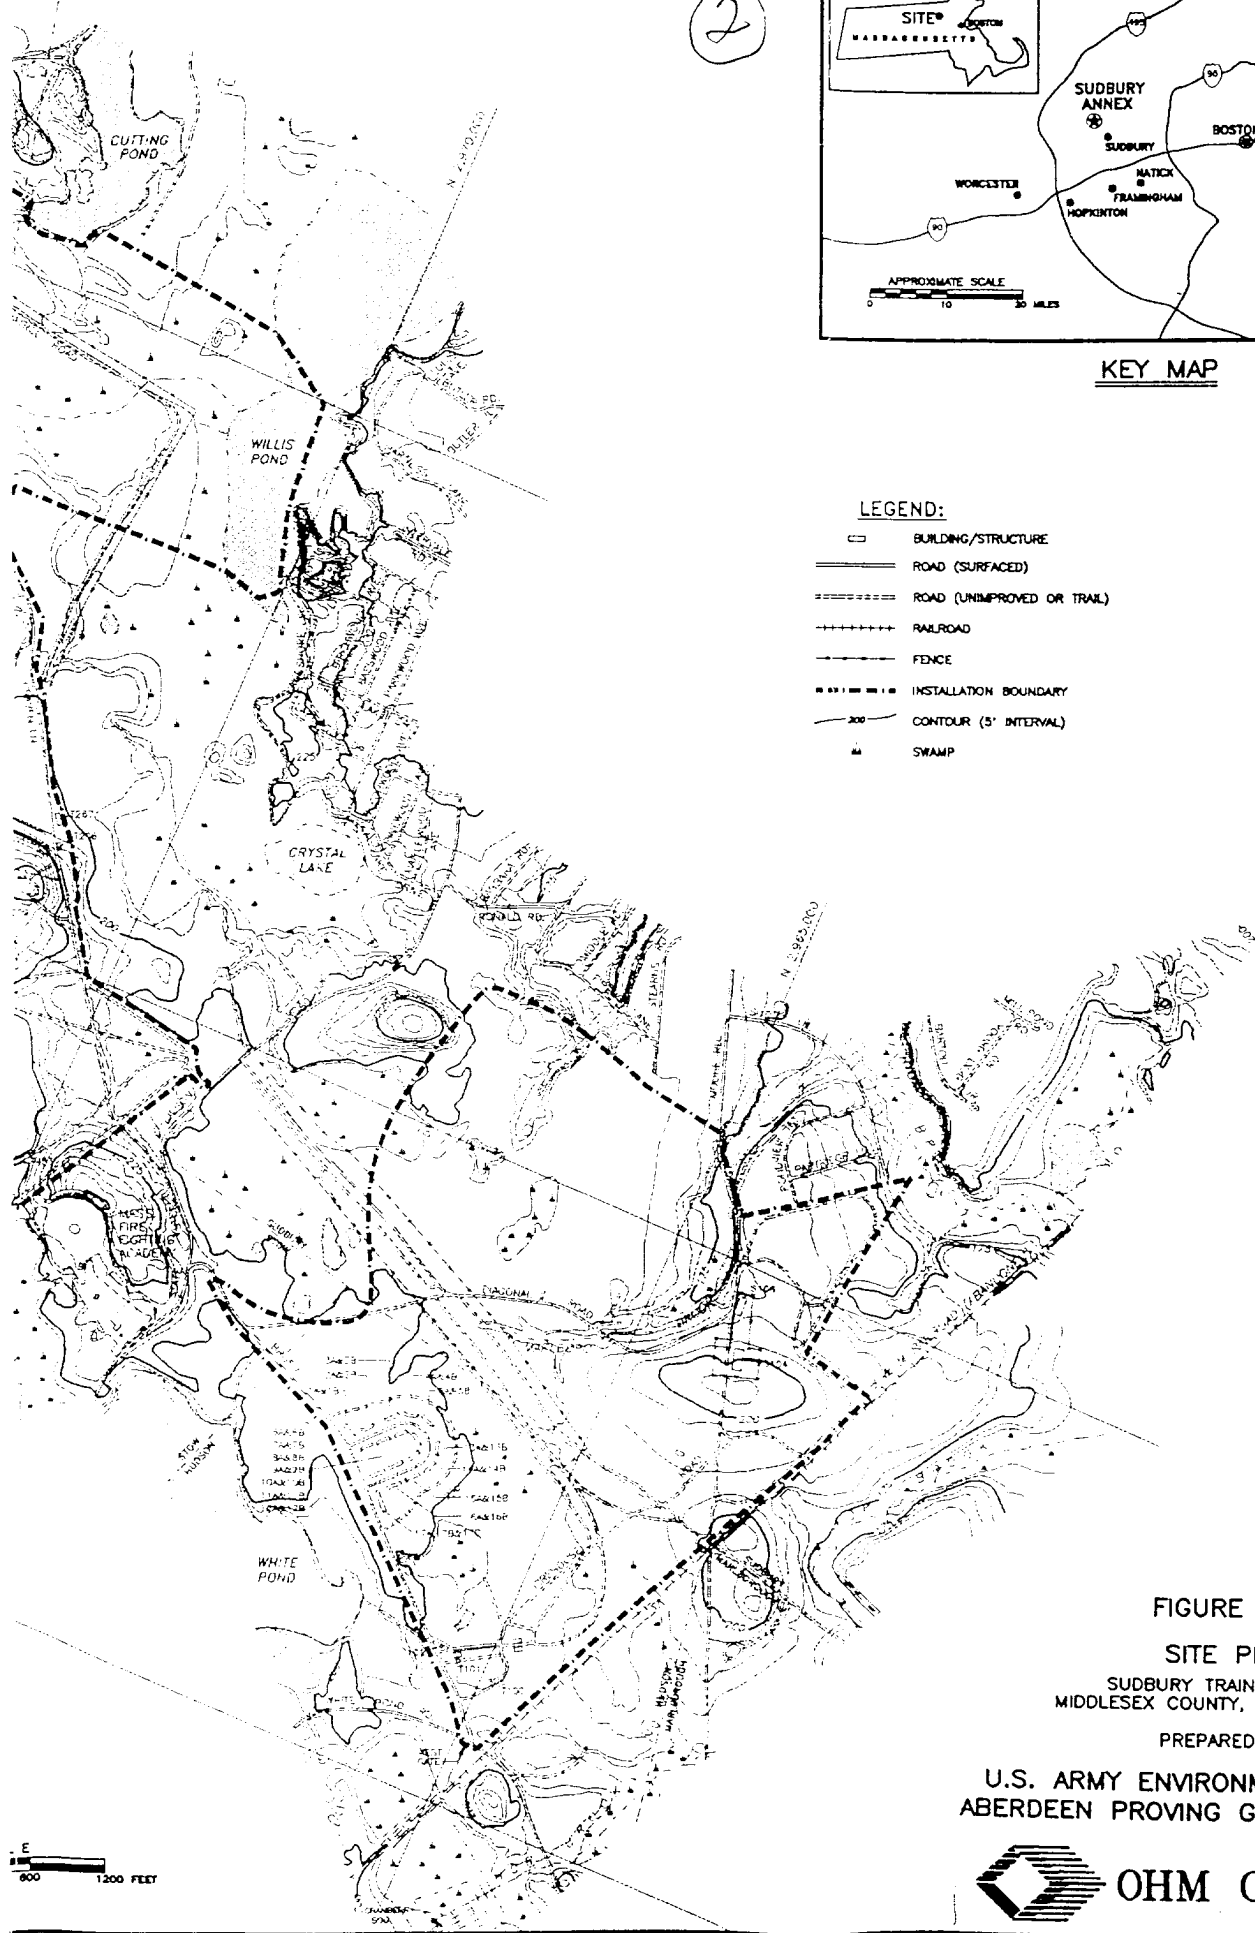
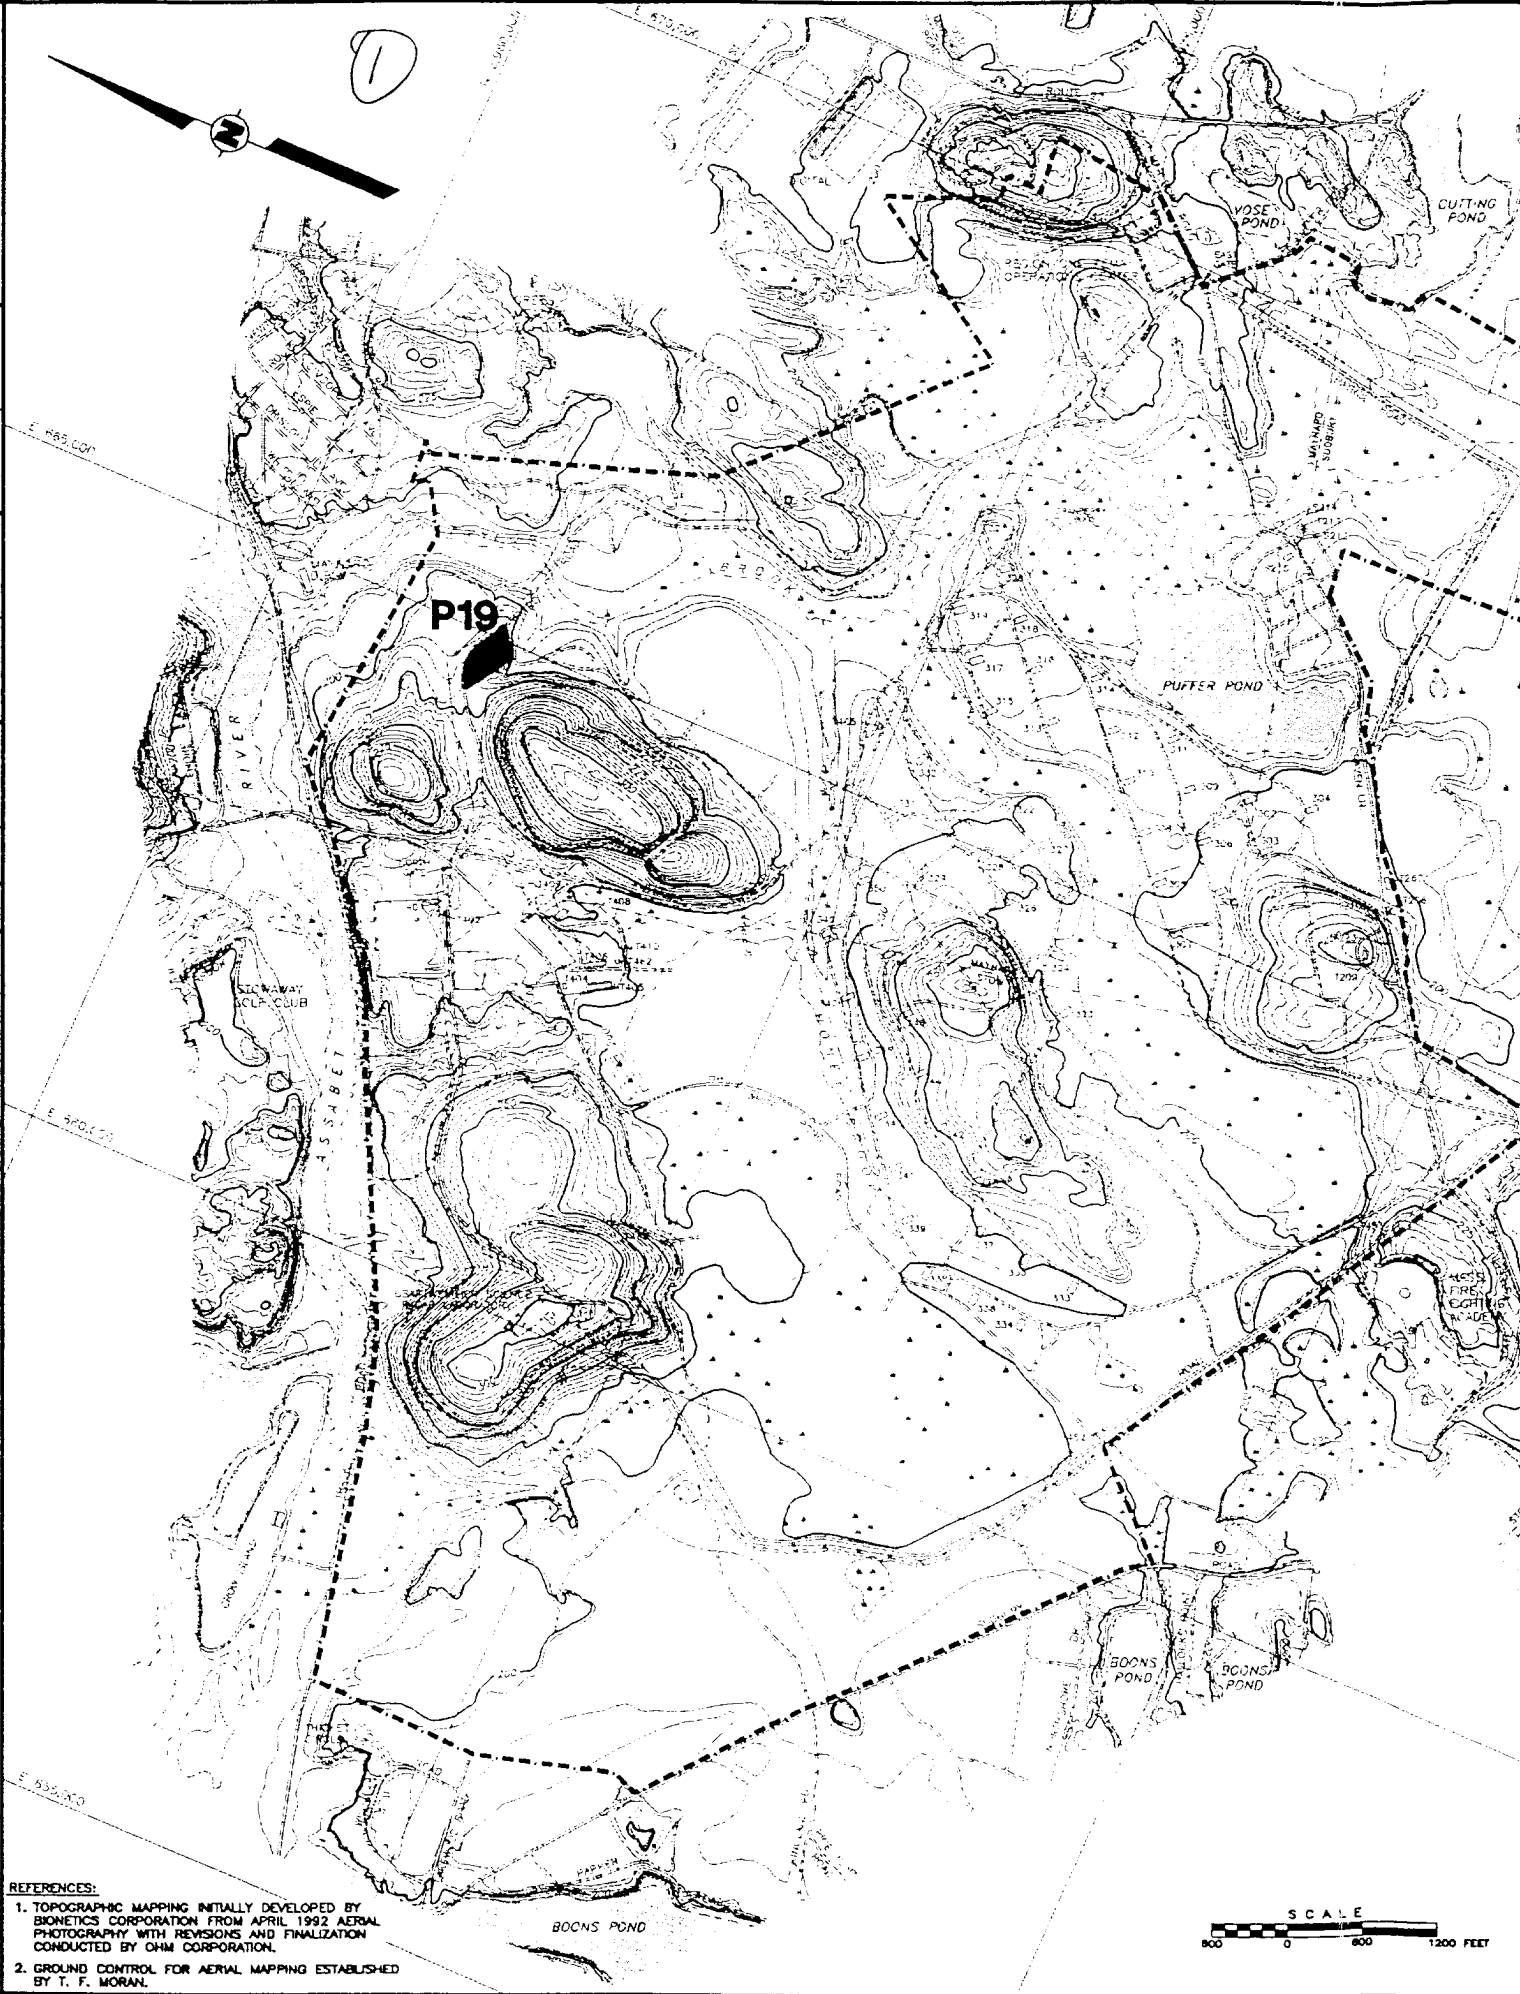
FIGURE 2-1

SITE PLAN

The Sudbury Training Annex is located 20 miles west of Boston, 12 miles northwest of Natick, Massachusetts and 2 miles northwest of the town of Sudbury in Middlesex County, Massachusetts. The installation is located in the Maynard, Massachusetts 7½-minute United States Geological Survey (USGS) quadrangle map. Figure 2-1 presents the site map.

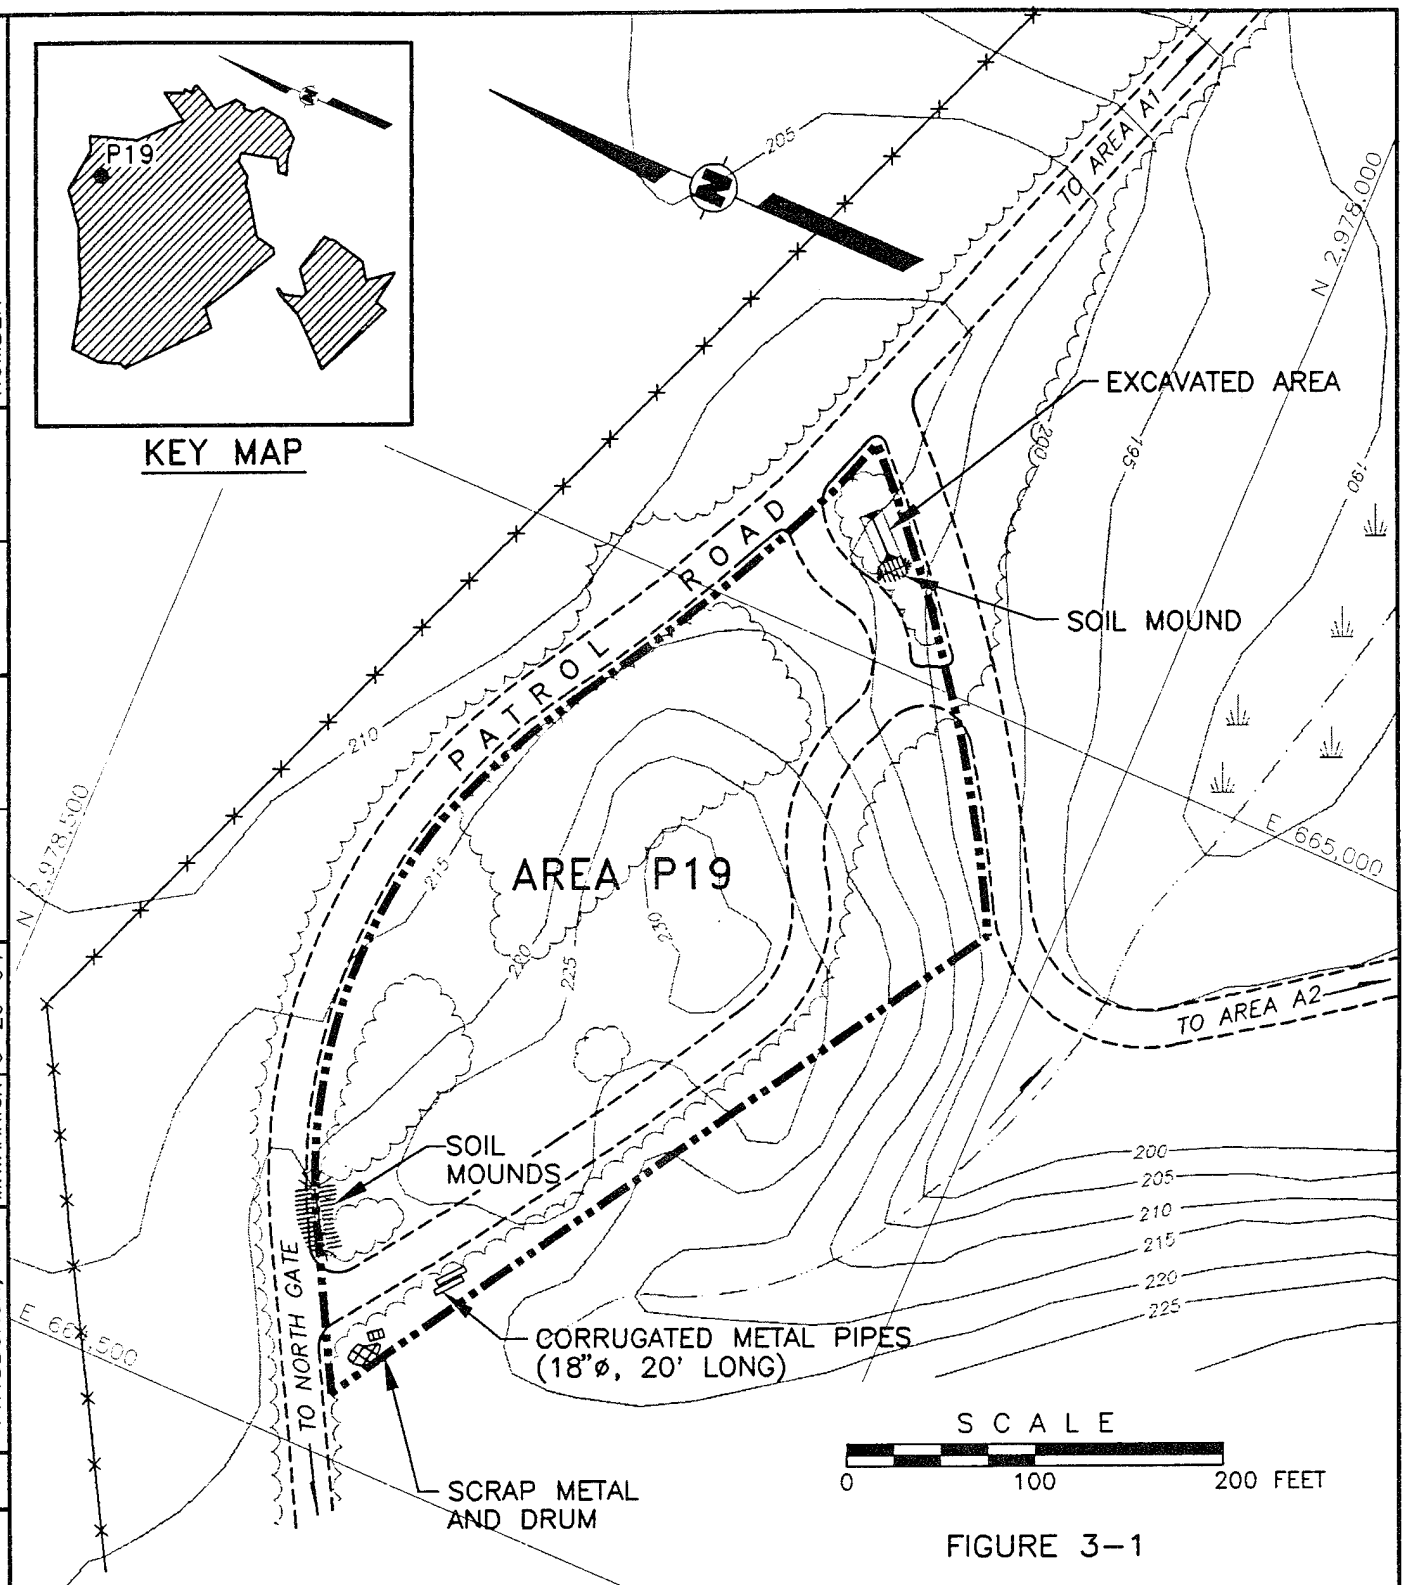
FIGURE 3-1

AREA P19
SITE MAP

Area P19 is located near the northern border of the installation on the south side of Patrol Road. The area is 500 feet north of Area A2 and 1,500 feet northeast of the North Gate. Figure 3-1 presents a map of the area. The surficial geology of this area has been classified as ground moraine (Hansen,1956). The area is a wide clearing situated on a small hill. The clearing is visible on aerial photographs.

Several small mounds, trenches, and pits were noted in the area which were believed to be the remains of fighting positions left by military training units. Record searches do not indicate disposal activities in this area.

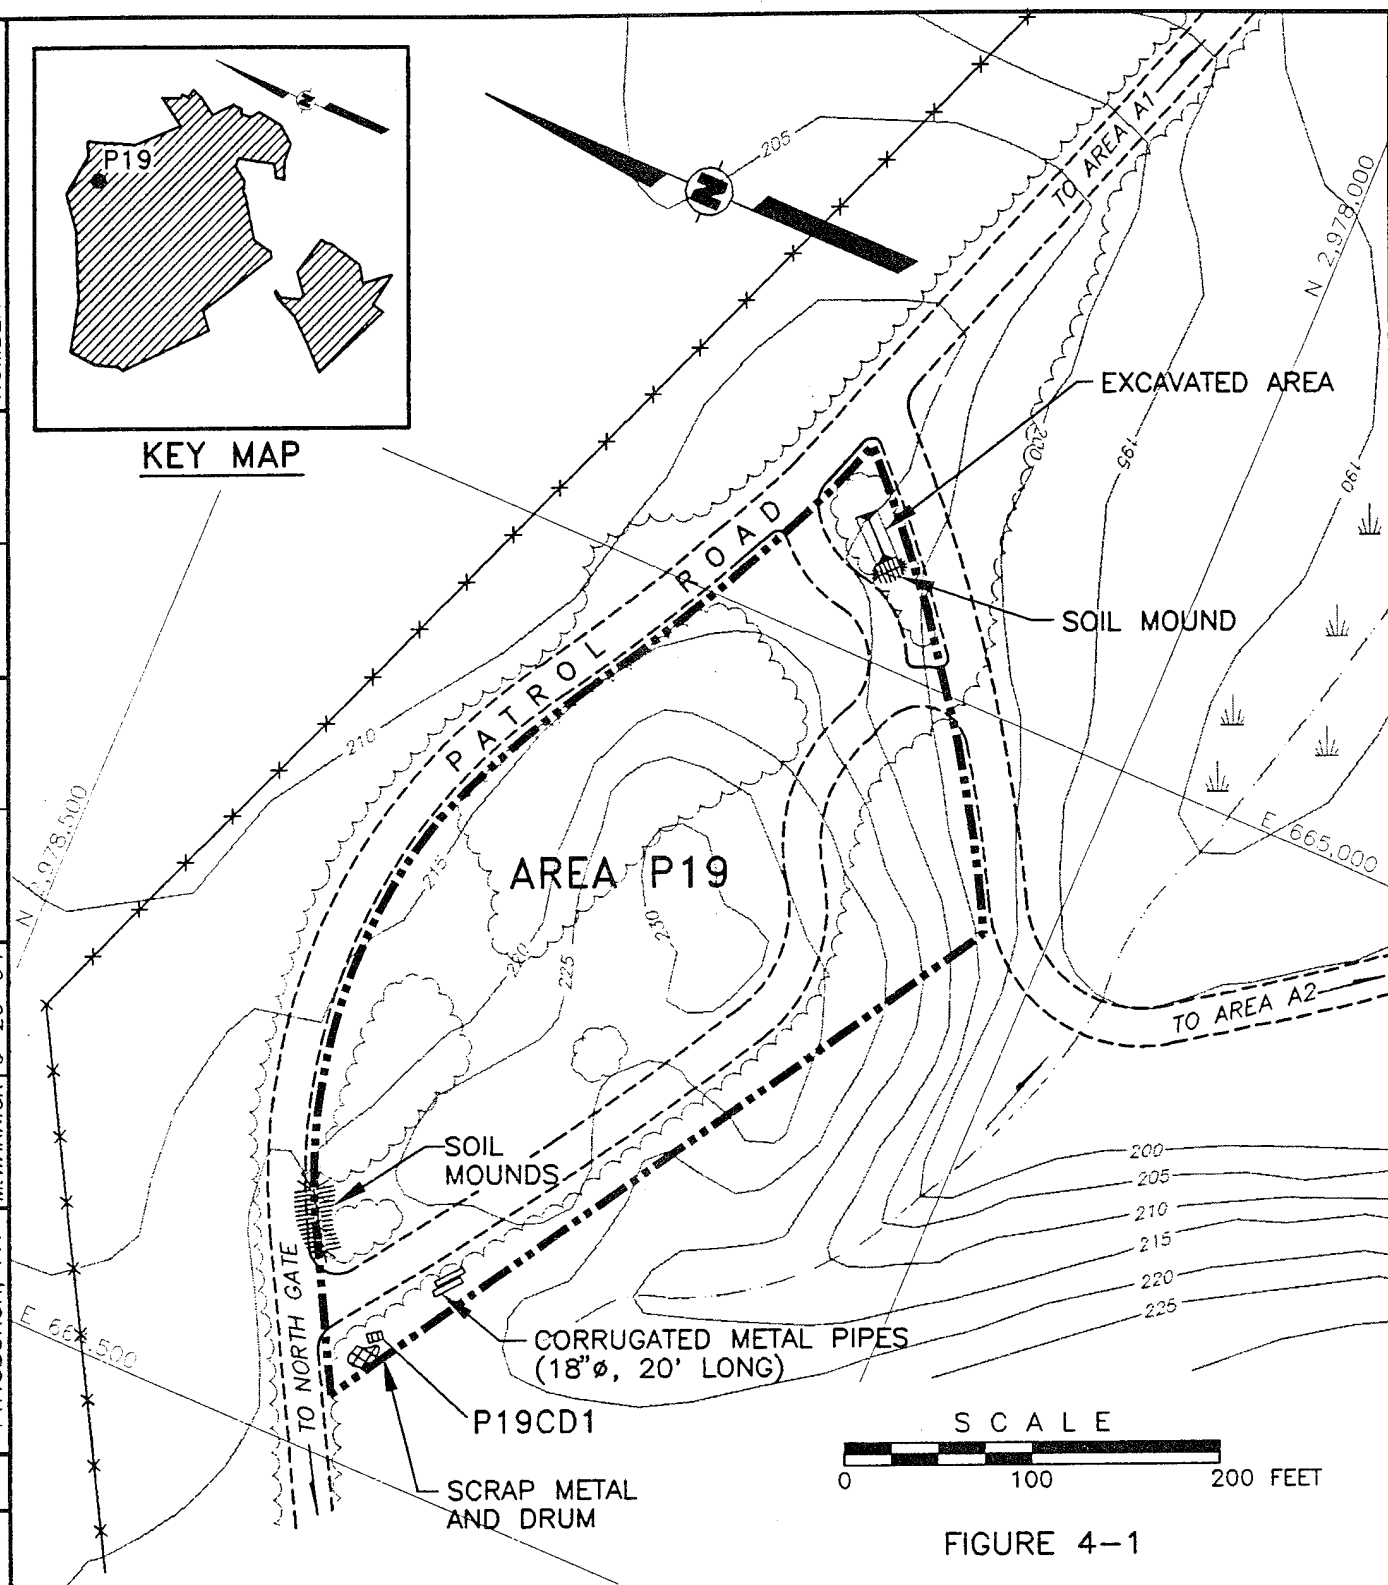
FIGURE 4-1

AREA P19 SITE MAP
AND PHASE II SAMPLE LOCATION
SUDBURY TRAINING ANNEX
MIDDLESEX COUNTY, MASSACHUSETTS

The single drum was removed and placed in a staging area at the old MFFA. During the Phase II investigation one confirmatory sample, P19CD1, was collected and analyzed for TCL volatile and semi-volatile organics, pesticides/PCBs and TAL metals. The sample location is presented in Figure 4-1. No staining, unusual odors, or PID or radiological readings were noted during sampling. A complete list of positive detections from Area P19 is provided in Table 4-1. The pesticides, DDT and DDE, were positively detected at 0.0341 and 0.0751 $\mu\text{g/g}$. Among the positive metal detections, arsenic, barium, cobalt, lead, and potassium were detected above their respective 95% UCL for background soils, however arsenic, barium, beryllium, cobalt, and potassium are not considered contaminants of potential concern since their detections were within the range concentrations in the background samples. Selenium was detected at 0.64 $\mu\text{g/g}$ and does not have a background level.
